LAND CORNER RECORD

Index: T-15	Corner: C1/4	State of Indiana - Hoosier National Forest		
Section: 27	Township: 7N	Range: 1E	P.M.: 2nd	County: Monroe
Coordinate:	Lat./N: 1371759.713	Long./E: 3147856.564	Datum: NAD83 IN West Zone, US Survey Feet

MONUMENT RECORD
State of Indiana - County of Monroe

Corner ID: Polk O-19

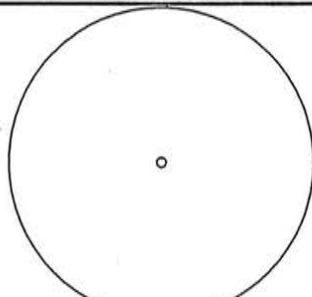
MONUMENT SKETCH	NARRATIVE REFERENCE:
	Monument is an iron pipe with a 3" brass cap found 0.3' above grade, a carsonite post is located 1.5' north of the monument, located 40' south of an east-west running drainage, on the northern side of and east-west running ridge, surrounded by mature forest, 400' S70°E of a one story house, +/- 200' east of a field with an electric rope fence, 40' S70°E of a large Poplar.

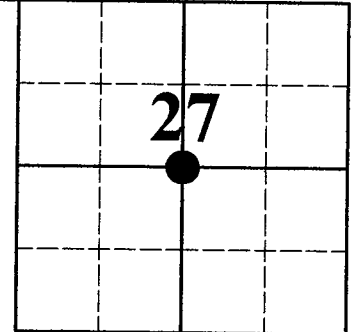
RECOVERY TIE DRAWING
Field Book 41 Page No. 45

Monument Description & Remarks: 3" Brass Disk nothing stamped. Survey Sign 3ft above ground at pt. C

- A - 3" Brass Disk
- B - S 36° W 5.89' to MAG nail in 22" Red Oak
- C - N 87° W 3.10' to Survey Sign on metal fence post
- D - N 42° E 23.12' to MAG nail in 17" Pignut Hickory
- E - S 47° E 23.23' to MAG nail in 22" Yellow Poplar
